## SAINT ANDREWS WHARF - ASSESSMENT REPORT

TOWN OF SAINT ANDREWS

February 25<sup>th</sup>, 2026

Project No: 18959

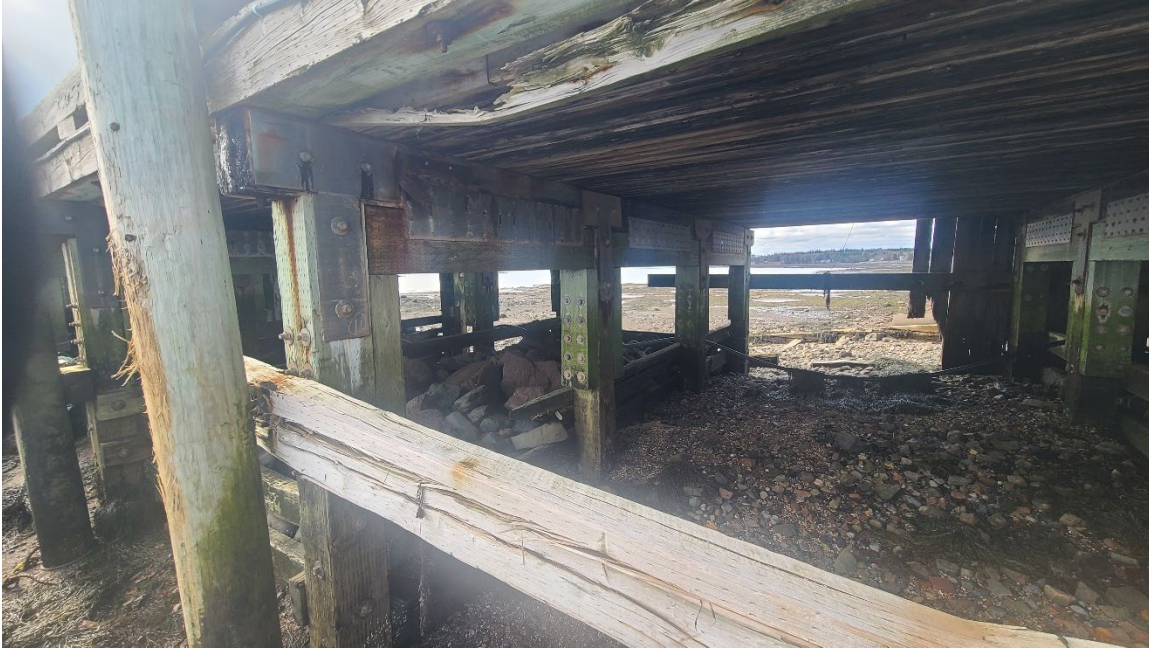
The Inner Approach Wharf is generally of wooden construction and had issues with wooden support columns, ballast floors and deck integrity. In 2000 this section of the wharf repaired by sistering new columns, reinforcing plates, deck supports timbers and replacing a section of the deck. In general, on-going maintenance has addressed previous issues except for the deck which is difficult to address because of the type of construction. A load limit of 9000 kg has been imposed on the deck. From the inspection the following observations were noted.

Figure 2: Collapsed Ballast Floor.

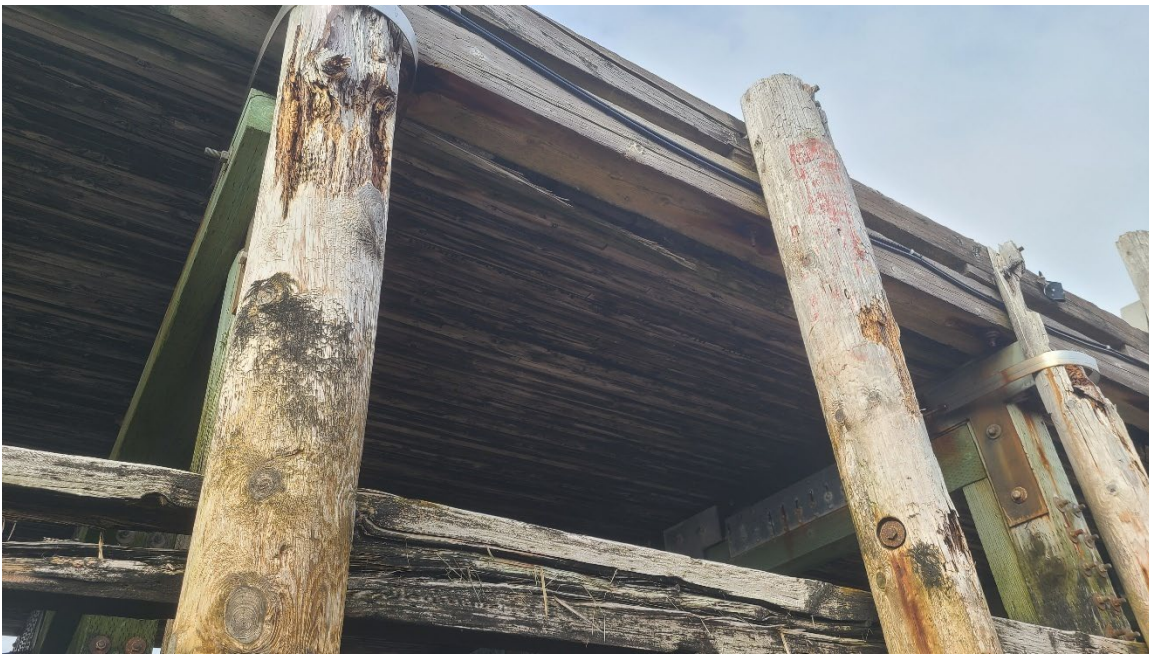
Figure 3: Between bents deck rot at edge of the wharf in numerous locations.

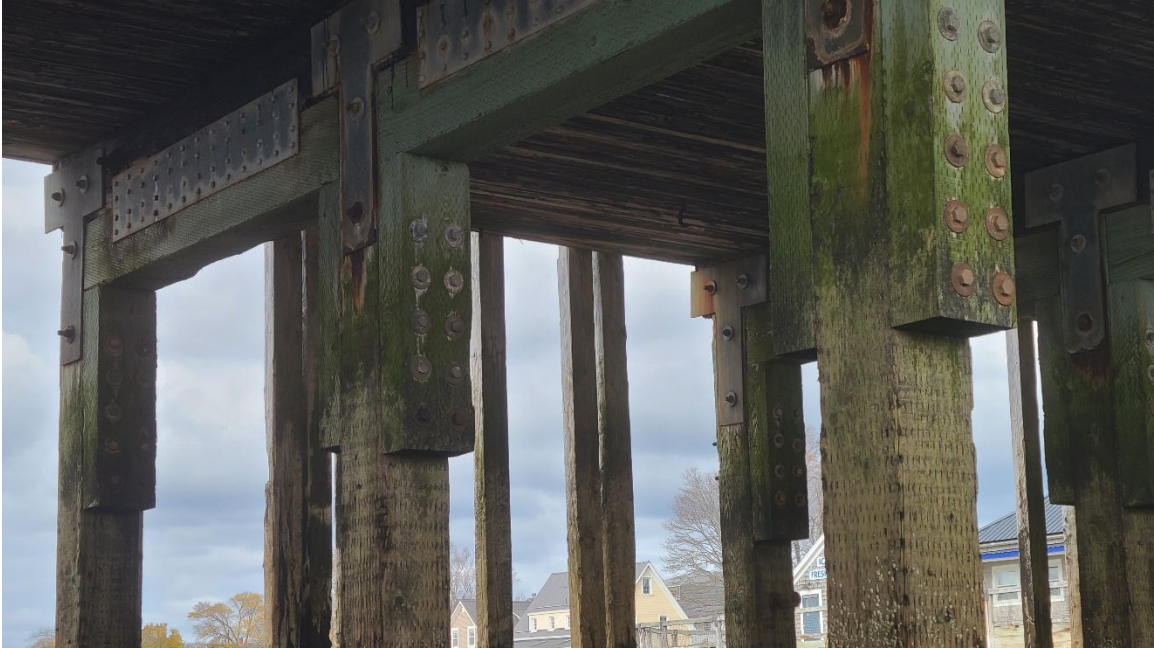
Figure 4: Typical repairs to pile bents.

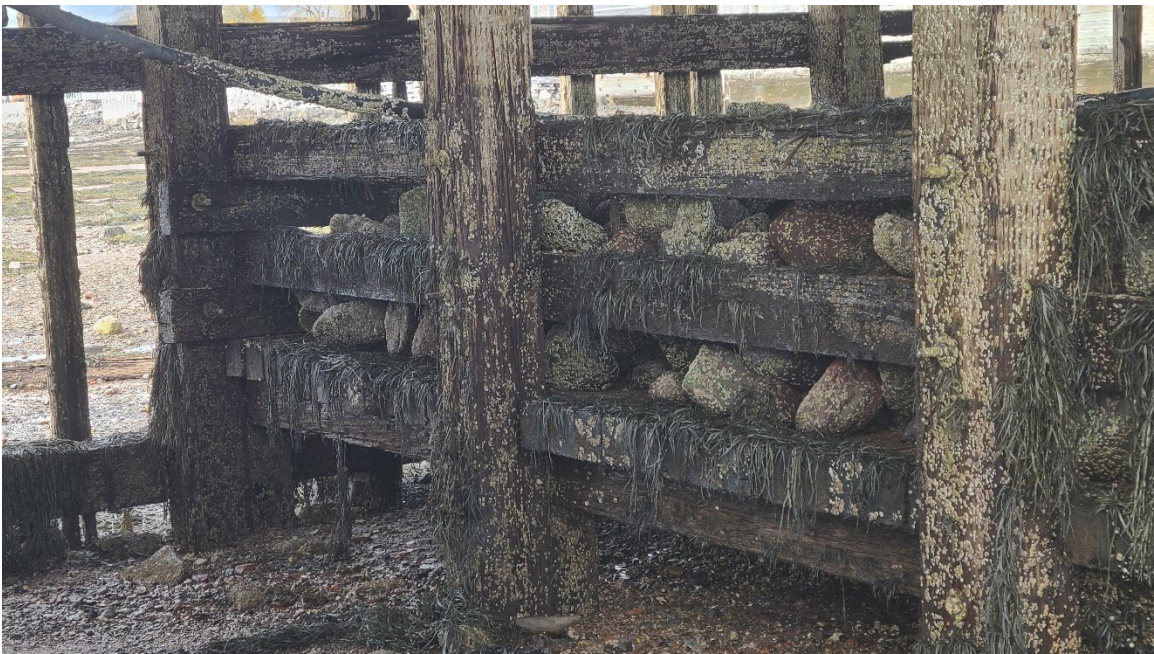
Figure 5: Line C trestle column is compromised.

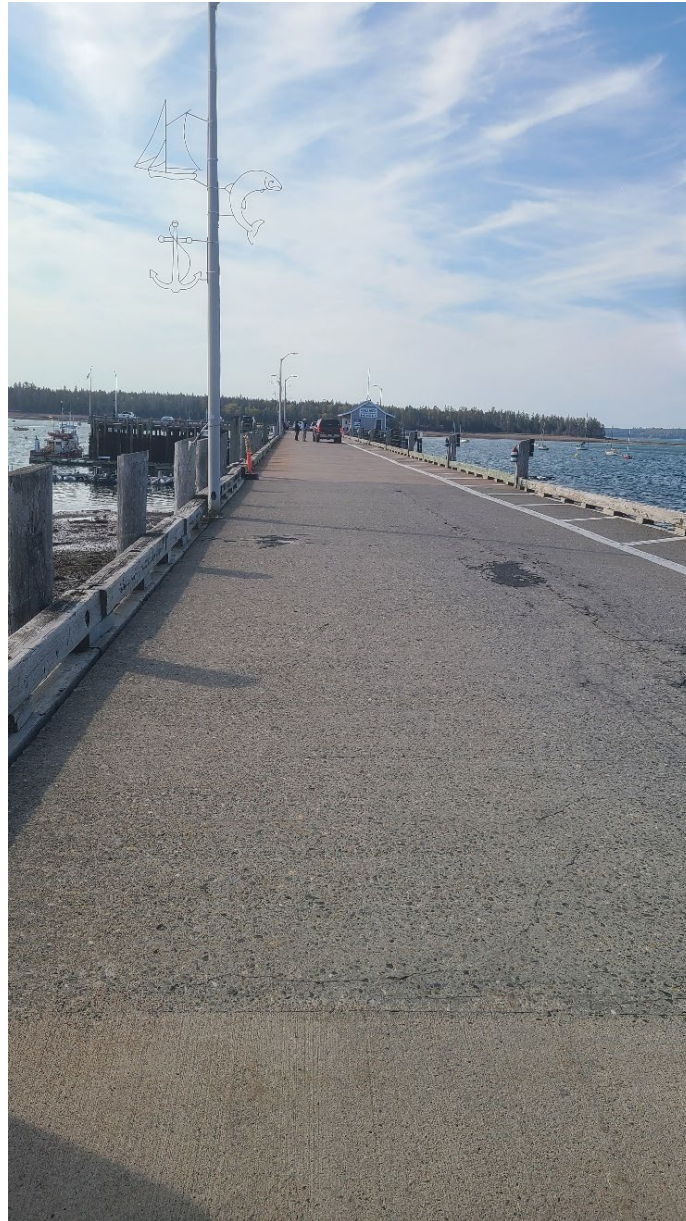
Figure 6: Inner Approach Deck with Repaired Section in Foreground with Centerline Cracks and Repairs.

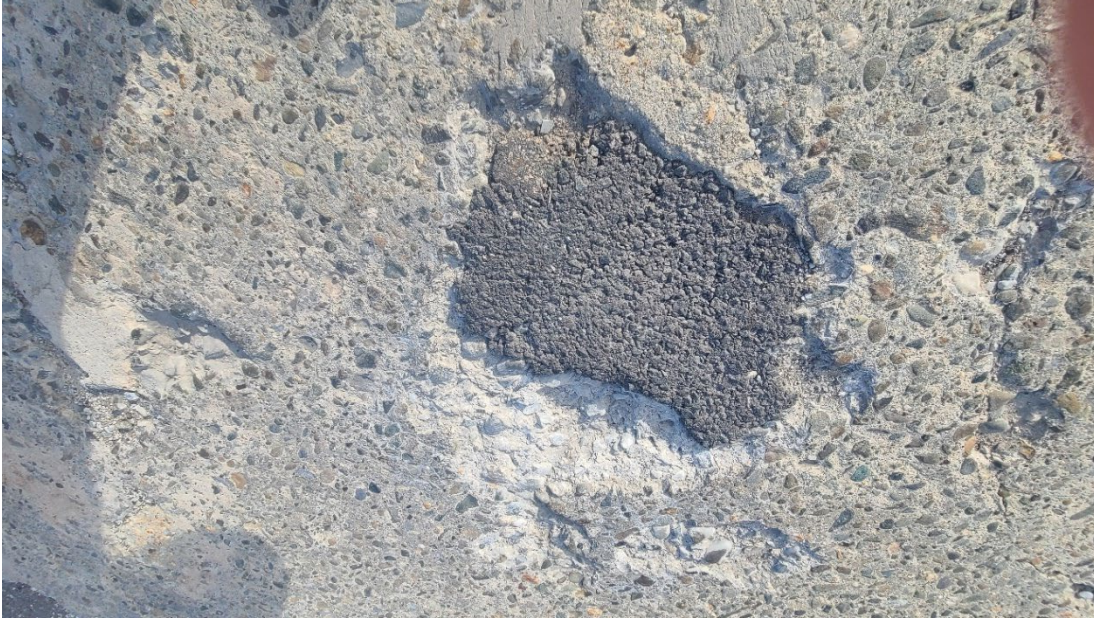
Figure 7: Inner Approach Wharf Deck Patch (200 x 450 mm) in Need of Repairs.

The thickness of the concrete decking varies along the approach and in places was observed to only be 90 mm. To sustain the 9000 kg load limit, temporary repairs can be made such as the installation of steel plates where significant spalling and popouts has reduced the deck thickness and corrosion of reinforcing steel.

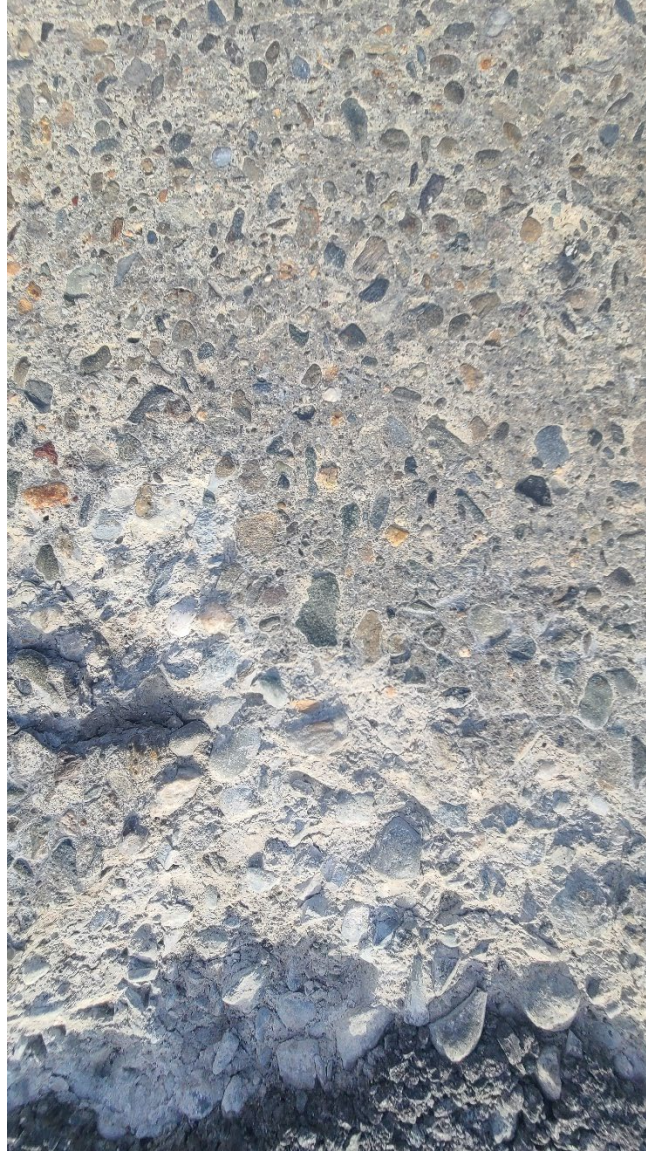
Figure 8: Alkaline Reactivity on Inner Approach Wharf concrete decking

The inner approach road decking is comprised of concrete and 75mm timbers. The concrete overlay is showing signs of spalling, alkaline reactivity and popouts. The concrete decking has had previous cold patch repairs completed in areas.

If work is completed to replace the concrete decking, a minimum thickness of 200 mm should be used, and a waterproofing membrane should be used below the concrete surfacing and above the precast deck panels. (See details on drawing C3.4).

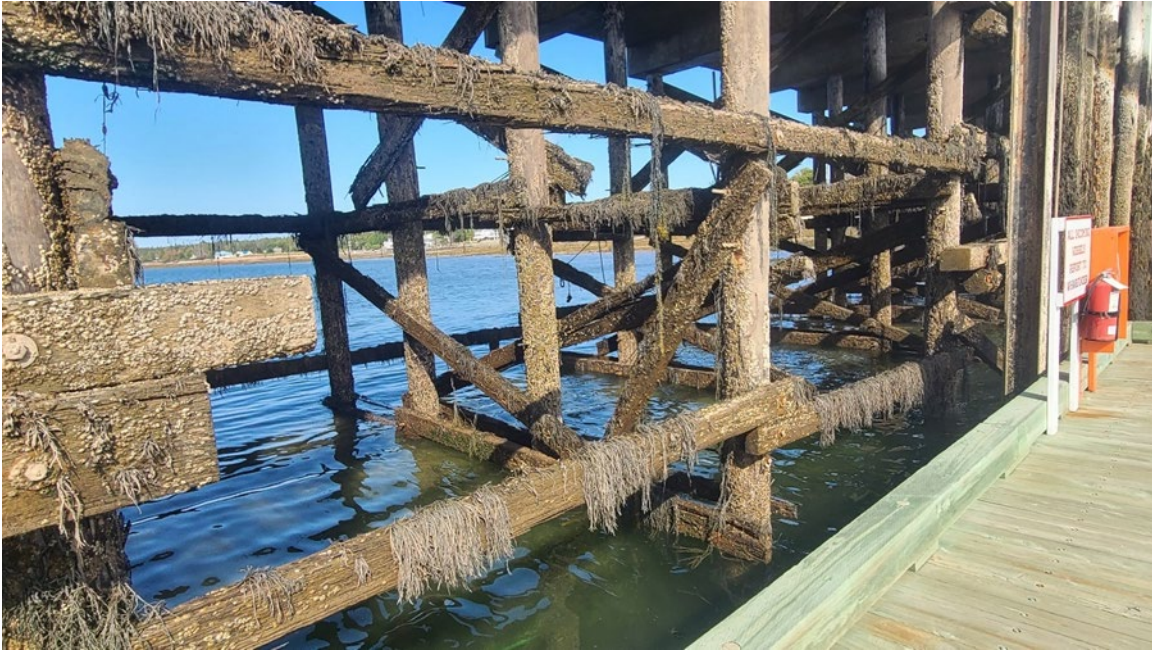
ties and bracing are deteriorated, damaged or missing. These members are treated wood that appears to have an accelerated failure.

Figure 9: Walers and cross bracing are in poor condition.

The Outer Approach Road require timber pile jacket and eventual replacement of all the Cross Bracing and Whalers.

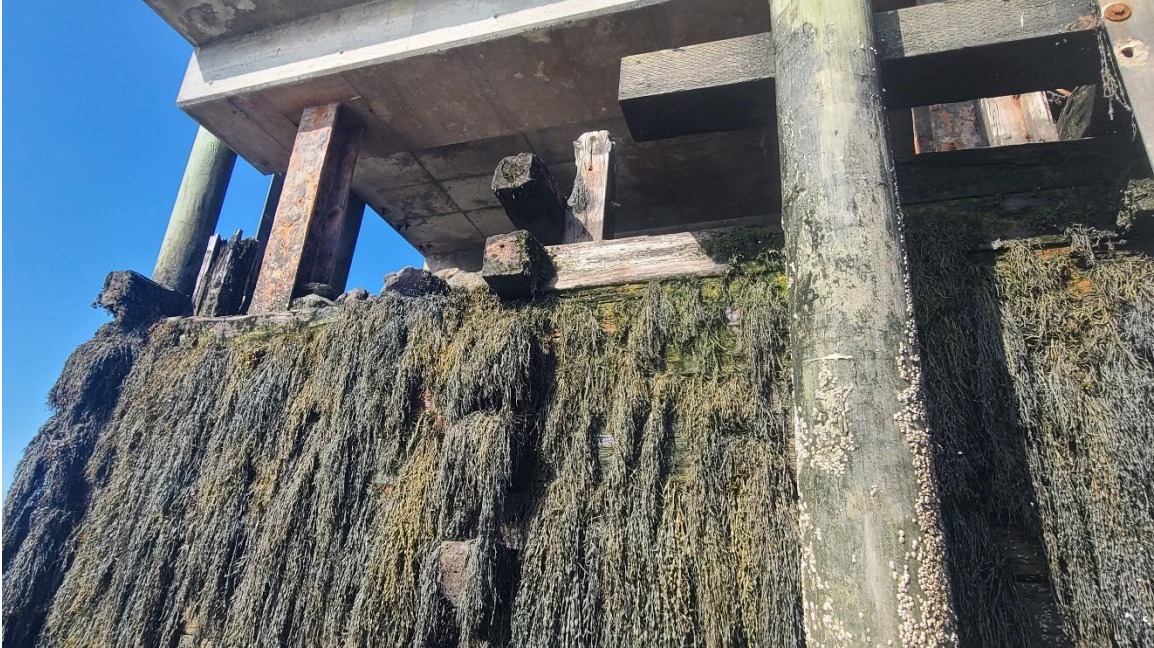
Figure 12: H Pile at Southeast Corner (Pile 22-A) with Corrosion in Splash Zone.

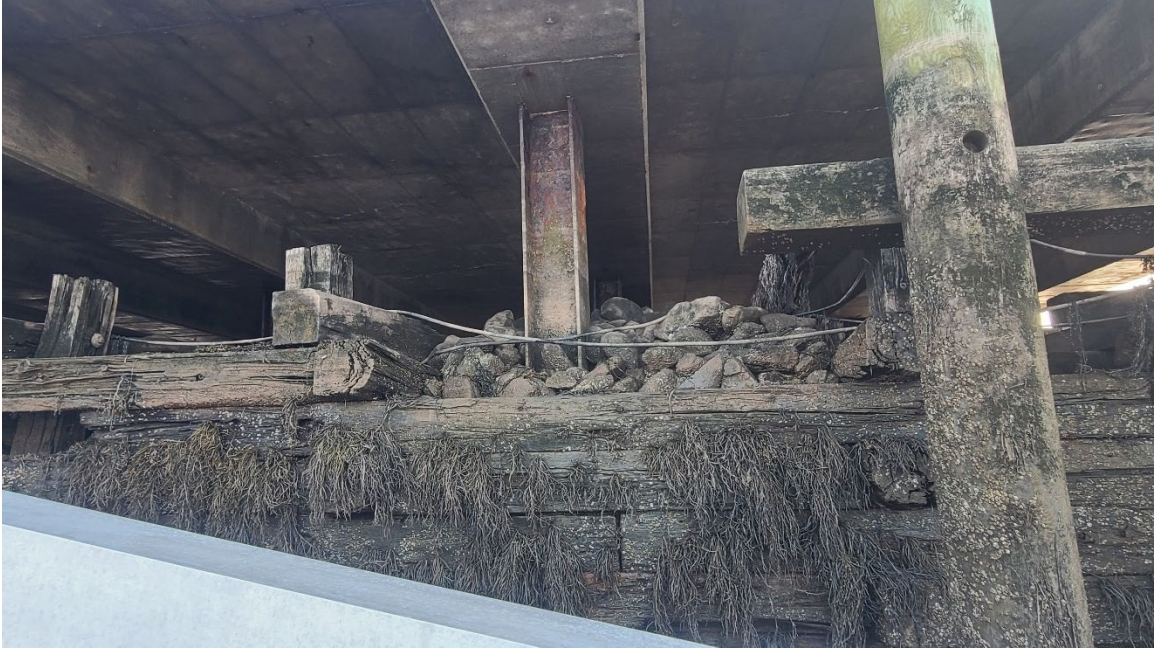
Figure 14: H pile at lines 11 – A and underside of deck in good condition.

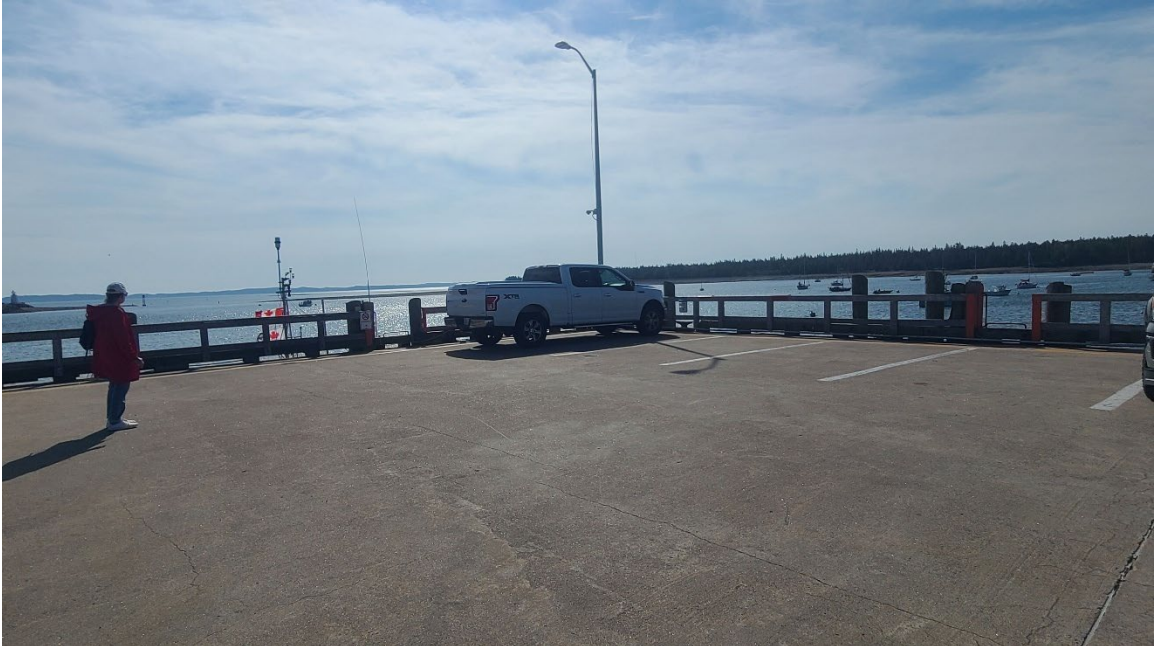
Figure 15: East end of wharf head deck in good condition.

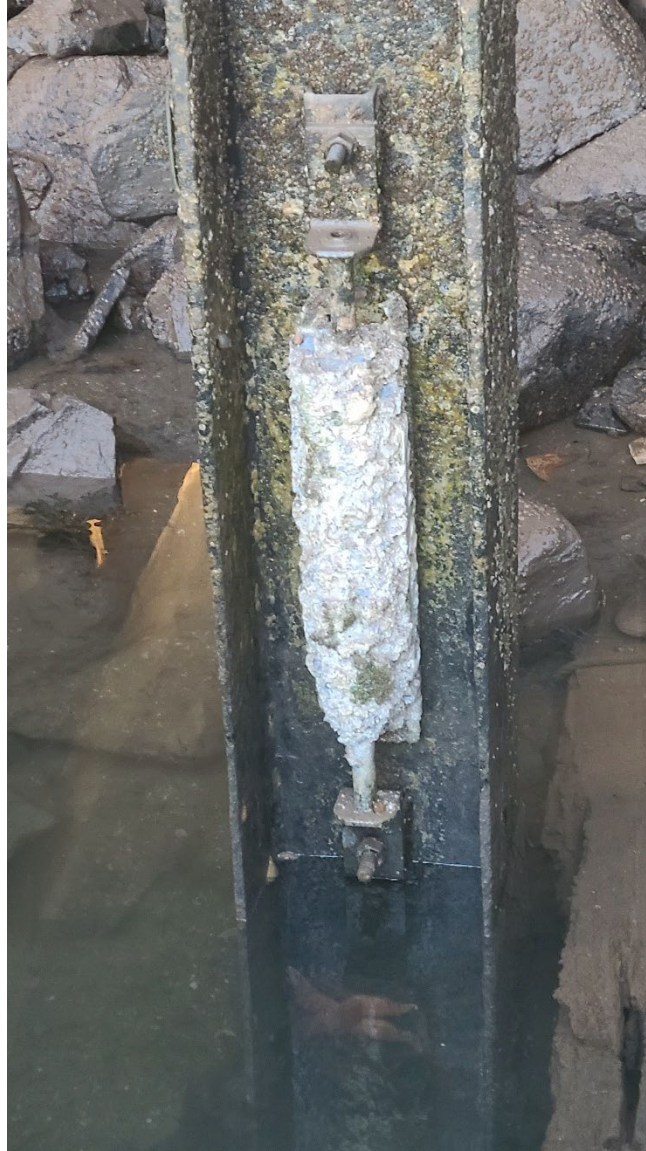
Figure 17: Structural H pile with significant hour glassing / loss of pile steel.

There are 51 Head of Wharf H Piles that need immediate repair. Recommendations on load restrictions will be forthcoming. In locations where steel H piles are identified as requiring repairs (See 'H Pile Repair Summary' Sheets). The proposed repair method involves welding of 30 mm thick steel plates to the web and flange at the top and bottom of the damaged sections, addition of a reinforcing steel cage and fiber-reinforced polymer (FRP) jackets. The jackets are to be filled with structural grout through ports on the jacket. (See details on drawing C3.5).

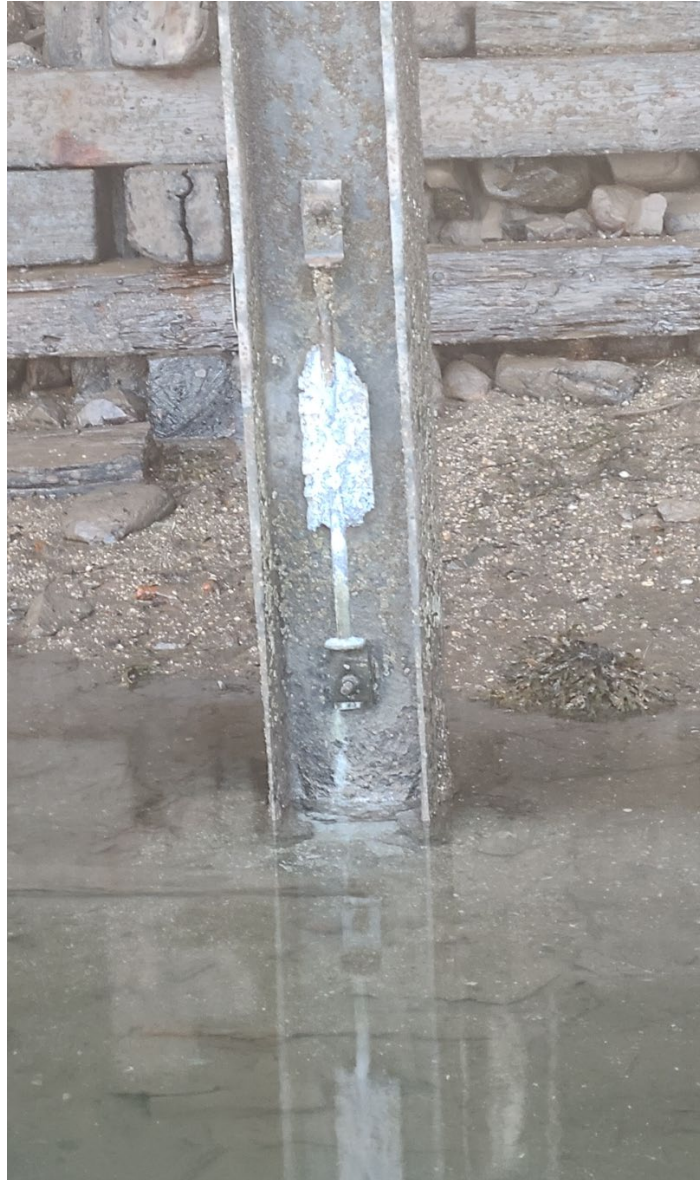
Figure 18: Structural H pile showing anode depletion and severe hour glassing / loss of pile steel.

If anode connection points on the piles can be lowered closer to the seabed this may reduce hour-glassing below the anode. It was noted that hour-glassing and loss of steel on H-piles were significantly worse below the anode locations.

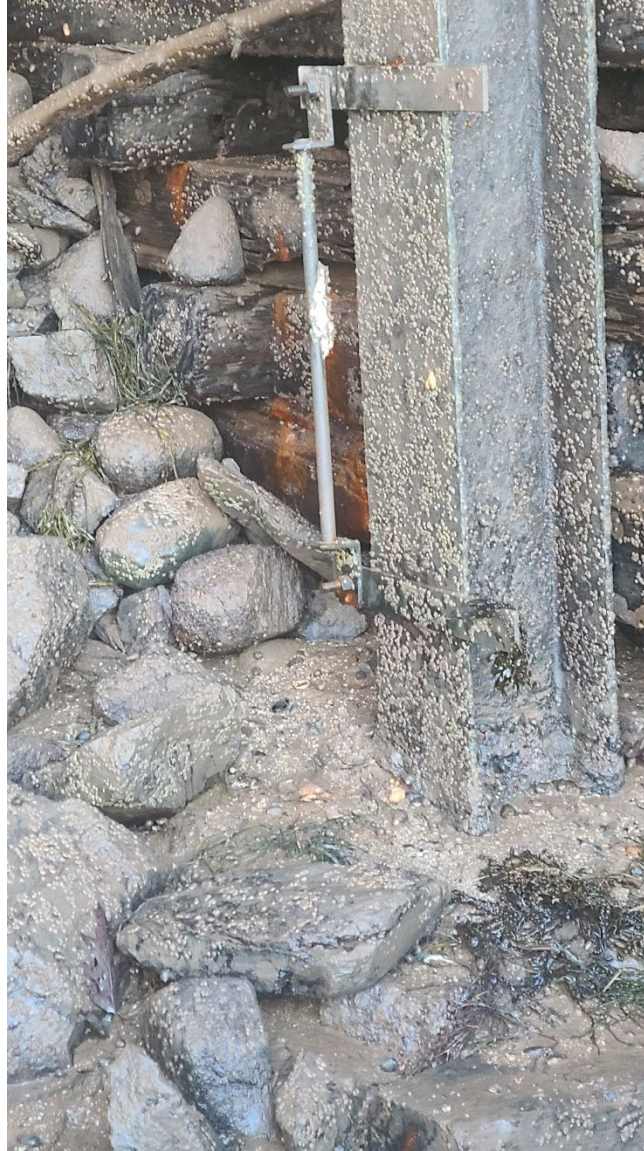
Figure 19: Sacrificial anodes in very poor condition.

The Head of Wharf structure is in very good condition except for, as shown in Figure 19 The H pile have significant loss of steel. We recommend that these piles be assigned the highest priority be repaired as soon as possible, i.e. this year. The jackets will be designed to carry the structural loading. See Drawing C3.5. The deck in the areas indicated on the drawing are subject the 9000 kg load limit. In the areas indicated on drawing C1.4 supported by piles with a square, the max total load for each of those areas is 9000 kg.

The zinc sacrificial anodes on the steel H piles (structural and guide piles) are showing signs of significant depletion in areas and should be replaced to slow down the electrolysis corrosion process. In order of severity noted from the assessment, the anodes should be first replaced on the North facing side of the Head of the Wharf. (Lines 15-22 Row E, and lines 15-19, rows C and D).

Second priority, would be to replace the anodes on the Western face of the Head of the Wharf H piles from Lines 1-13 Row A. Furthermore, the remaining anodes should be monitored and replaced as budget allows. Anode depletions of 5-20% were observed on the South face of the Head of Wharf, which would take final priority. The anode attachments need to be redesigned.

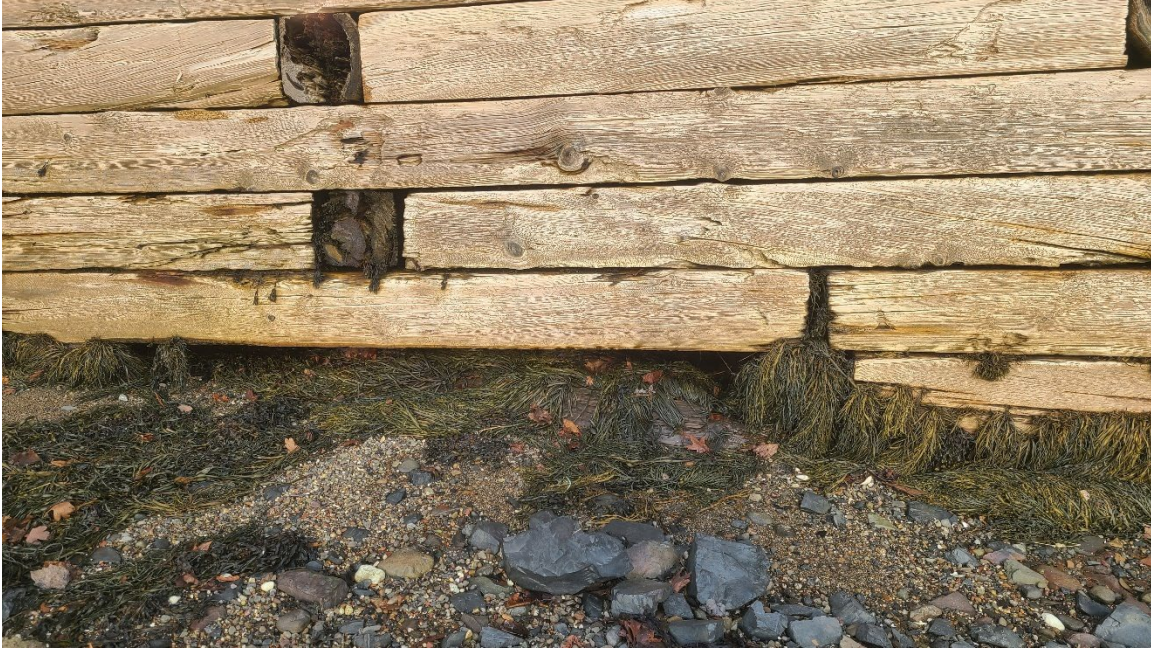
Figure 22: Void at bottom of Market Wharf (May be related to Figure 24)

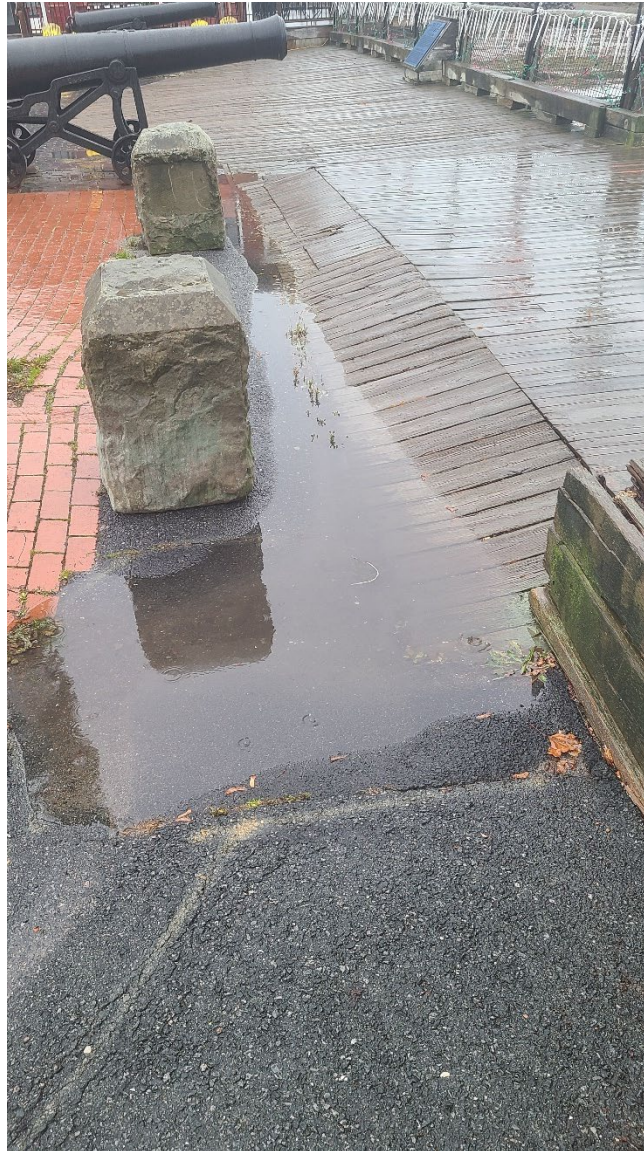
Figure 23: Subsidence behind Market Wharf crib structure.

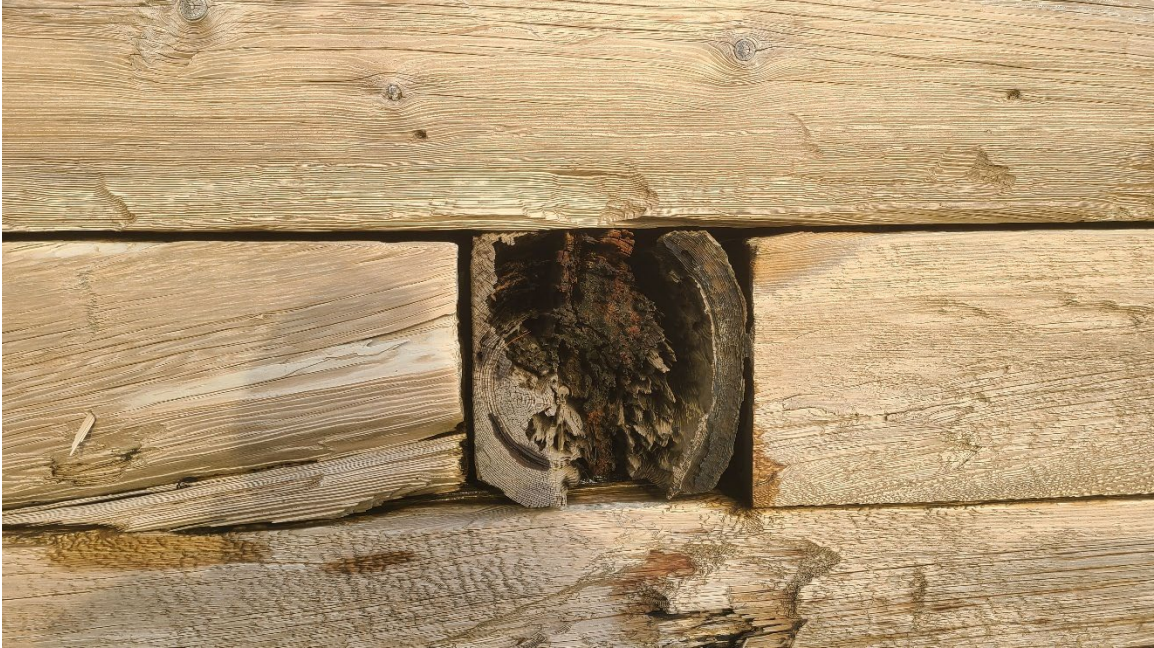
Figure 24: The end of the tie back is compromised due to rot.

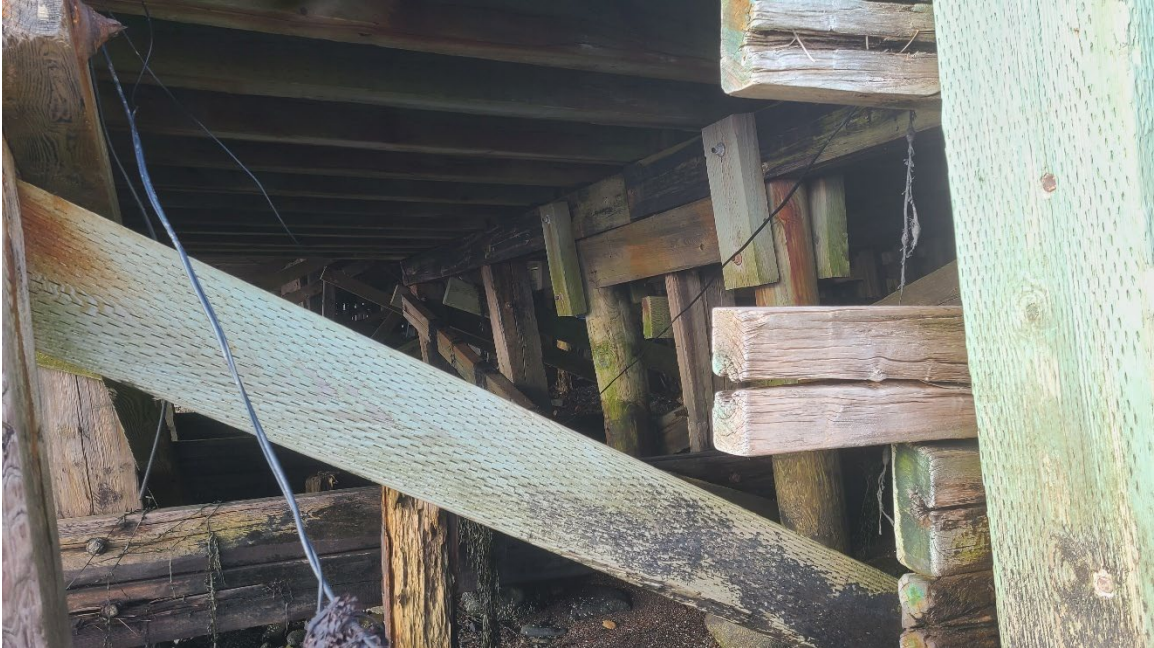
Figure 25: Leaning underside of Market Wharf deck.

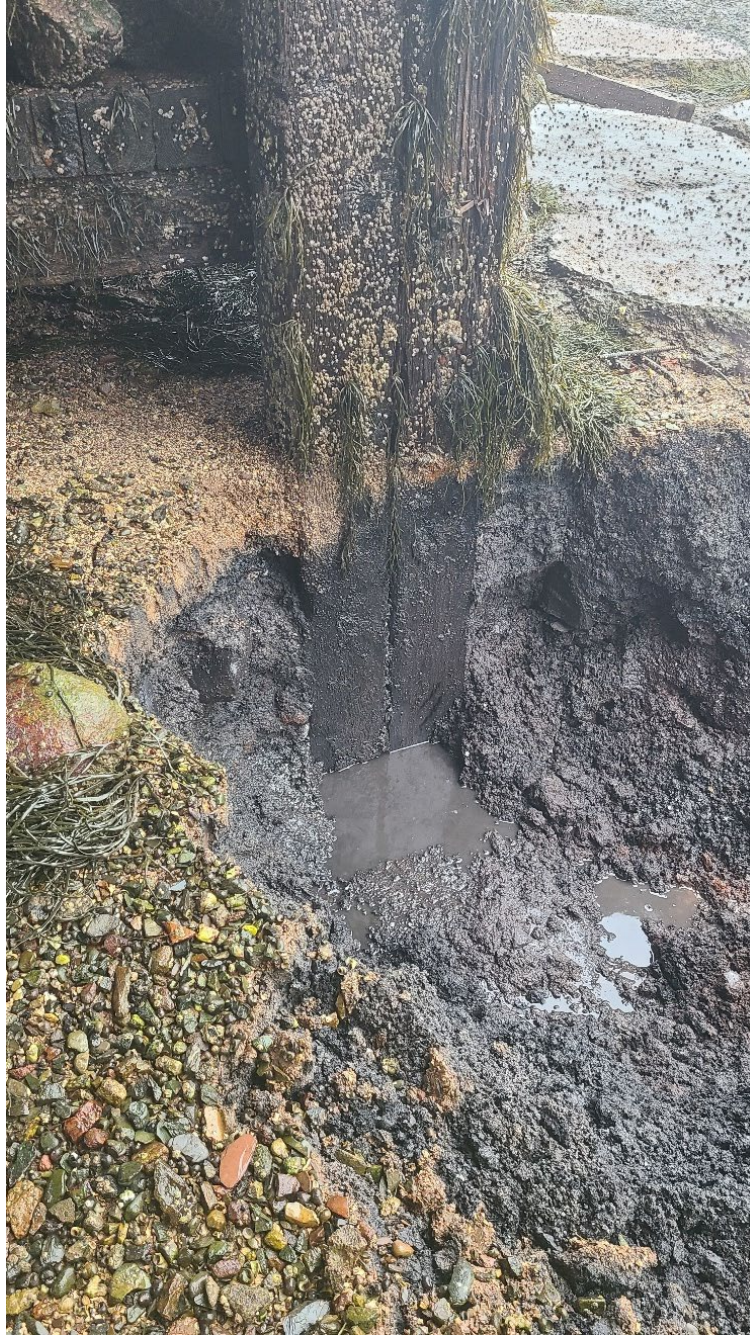
Figure 29: Test Pit #1

Two Test Pits were put down next to two columns to determine the depth to bedrock. In addition, the Test Pits were to confirm the founding of the trestle columns on bedrock. In both Test Pits bedrock was encountered at approximately 1.2 m. In Test Pit #1 the original column was founded on bedrock. The bottom of the sistered column which is connected to the original column was 100 mm above bedrock. The lower portion of the original column was sound.

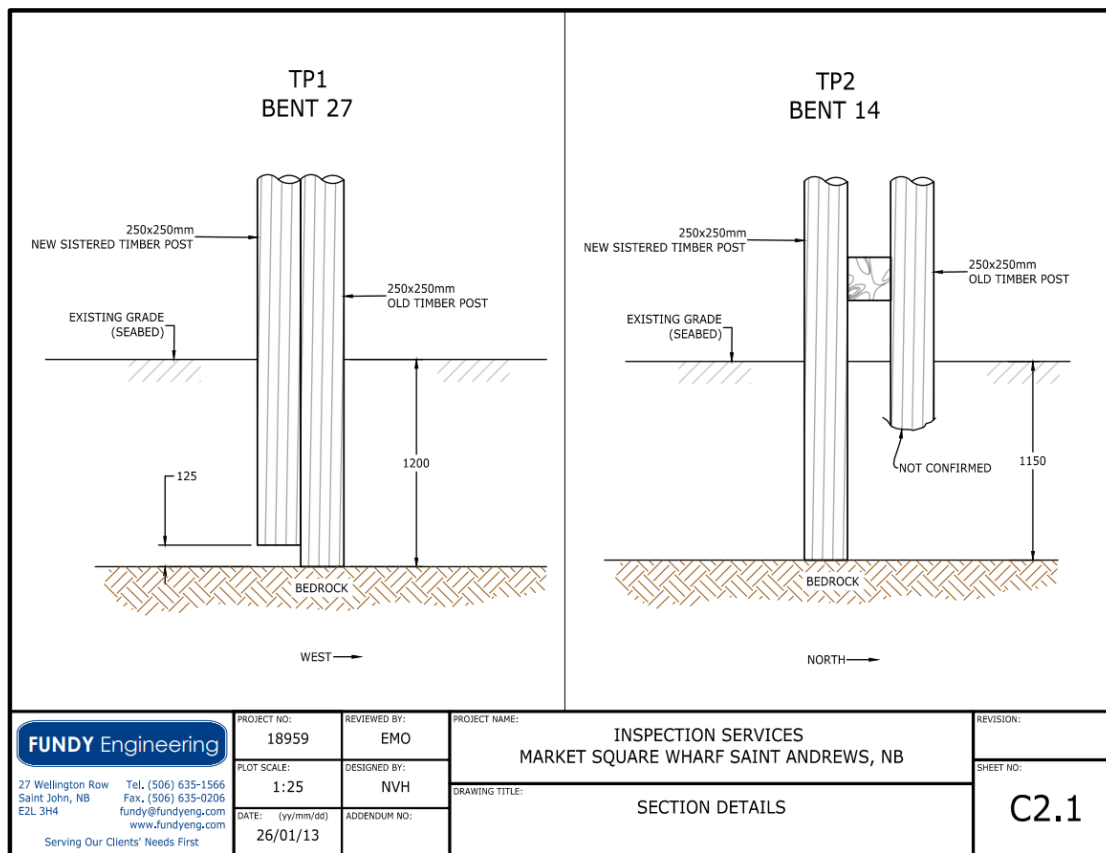
Figure 30: Test Pit #1 and Test Pit #2

In Test Pit #2 a new column was determined to be founded on bedrock.

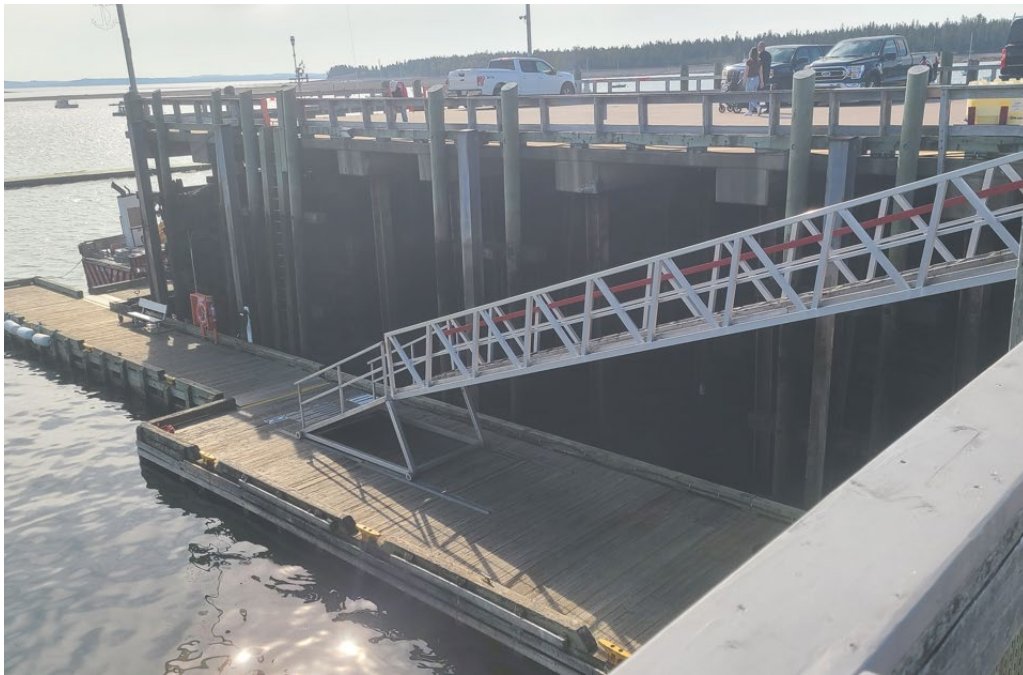
Figure 31: Eastern Gangway in Good Condition

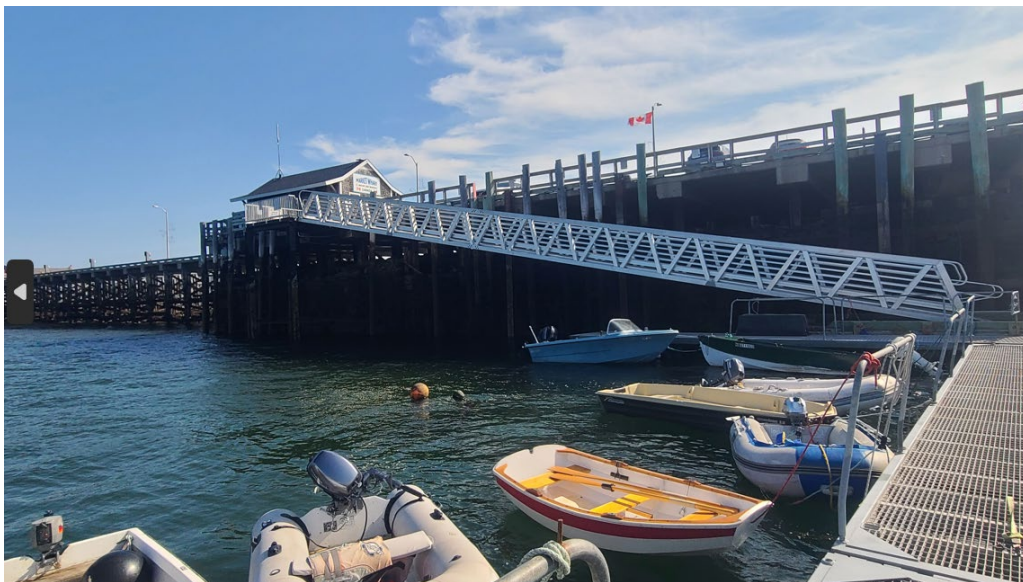
Figure 32: Western Gangway in Good Condition

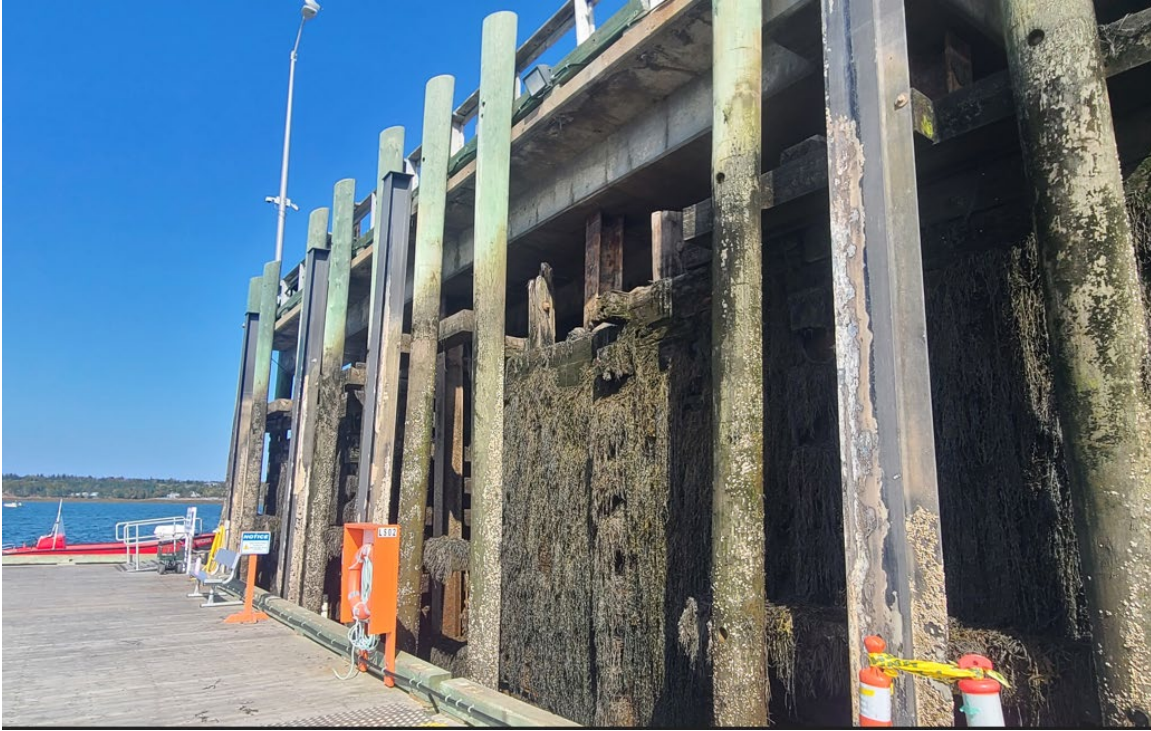
The main wharf guide piles for the floating docks are steel H-piles. The piles showed minor signs of corrosion within the splash zone of the piles but did not show any severe signs of hour glassing or cross-sectional area loss. The epoxy tar coating was still present on several of the piles that were assessed.

The timber fender piles showed signs of mild splintering and some natural decay but no significant cross-sectional losses. Over-time the splintering may worsen and checks may form. All fender and guide piles were examined for scouring and/or undermining at the base by the dive team, in which none of the piles exhibited signs of.

Figure 33: Timber Fender Piles and Steel H-Pile Guide Piles (South Face of Main Wharf)
